Manhole Inspection Summary

Manhole # **S39CC_024MH**

Insp Date: **3/5/08 1:18 PM**

Location Address: **1000 EAGER ST**

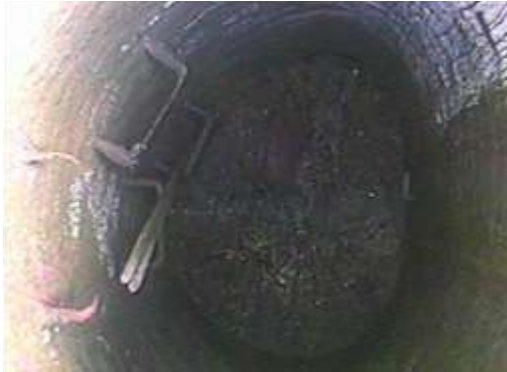
Defect 2

Condition: ☐ Sound ☐ Cracked ☐ Root Intrusion ☐ Deteriorated ☐ Leaks ☒ **Debris**

CHANNEL DEBRIS

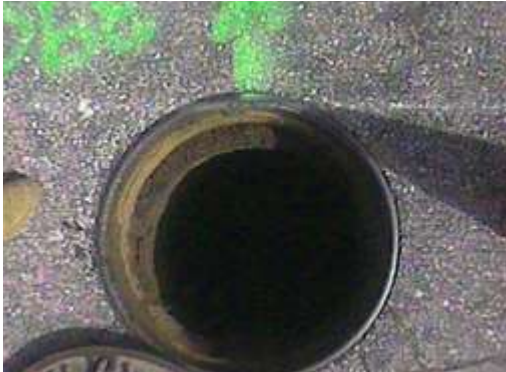
Defect 1

Offset: **2** (in.)

FRAME OFFSET

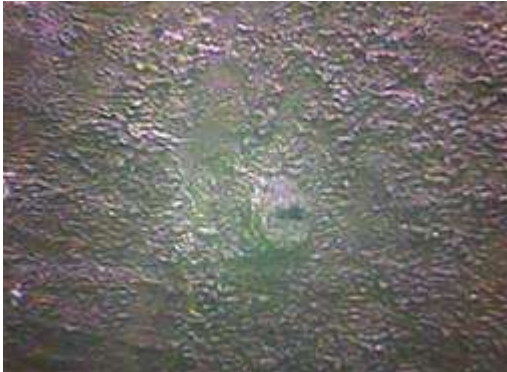
POSSIBLE ILLICIT CONNECTION

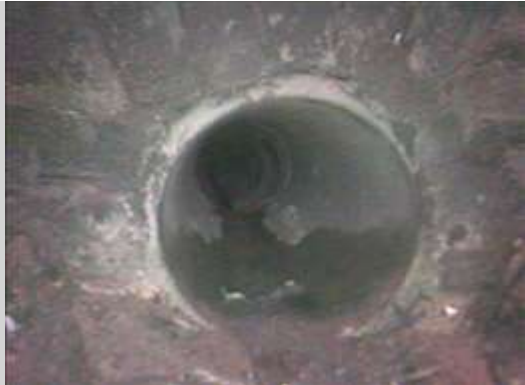
12 O'Clock Outflow

8 in. Circular Gravity Sewer
Pipe Out @ 12 O'Clock
